SECTION 4 BODY

- 1 A general dissertation on body alignment
- 2 Timbers for body building

GAZETTE NO.29 MARCH 1985

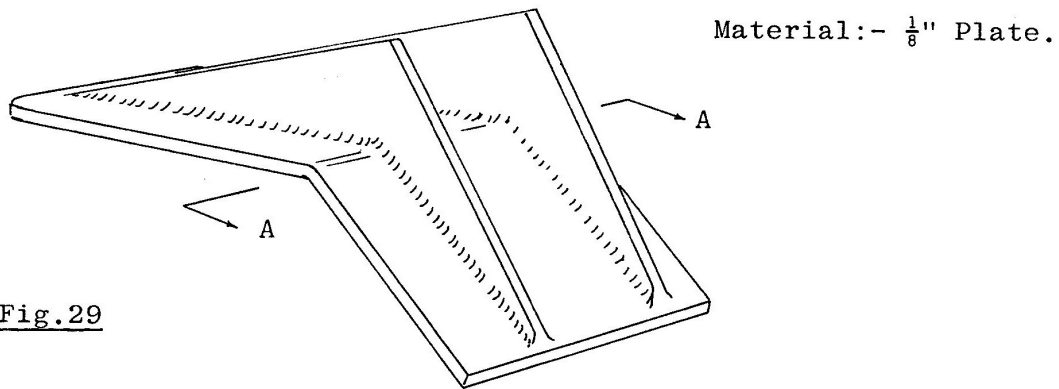
Fig. 29

In the case of the Salisbury axled cars ('F' and 'G' types) the plot is even worse, since the bottom plate is removed to allow the road spring to be sited directly over the axle, inside the chassis. The resultant 'Top hat' shape is very weak, and is usually found to be deformed into an elliptical shape. The cure is to fabricate a bottom plate assembly strong enough to have a far greater resistance to longitudinal compression: see Figs. 29, 30 and 32.

ALTERNATIVE CHASSIS MODIFICATION.

The above fabrication might be easier to fit, since it will only be necessary to remove the original base plate, leaving the flanges of the side in their original shape.

The vertical stiffening flanges should be positioned so that they, and the associated weld fillets fit inside the box section. (See Fig. 30).

Note that the rear of the chassis should be jacked to stretch the side plates while the new assemblies are welded in place, although it will tend to drop a little as the welding cools off. Final adjustments will then need to be made to the attitude of the rear of the body by means of shims at the rear body mounting points.

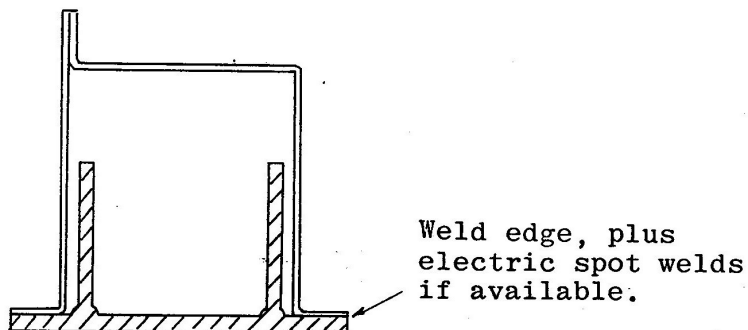
Fig. 30

Cross section at A-A showing position relative to existing chassis member.

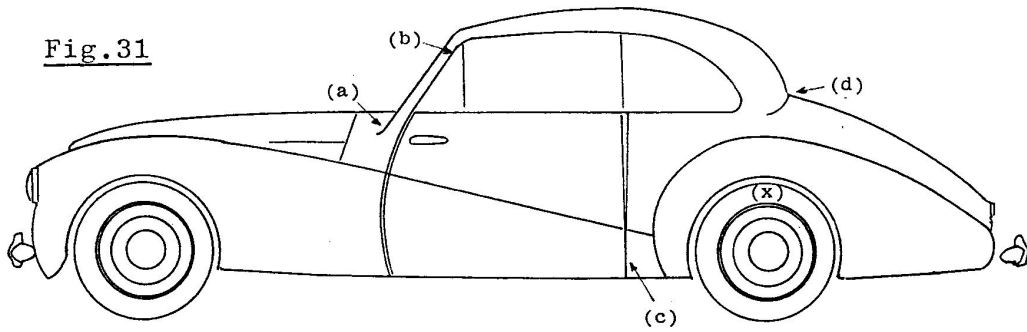
Fig.31

It will be apparent that when all this has happened, the tail of the car will drop. With reference to Fig.31, one may regard each rear wheel arch/wing/quarter body assembly as a fairly rigid unit rotating in a clockwise direction about an axis through the top of the chassis (x). It will therefore be apparent that when this happens, the lower front edge of the wing assembly will push the bottom of the panel at 'c' forward so that the door gap is closed at this point. Healeys with paint rubbed off the door in this area are extremely common!'

It will also be apparent that the roof or hood will be pulled back so that the windscreen pillars impinge noisily upon the quarter light frames at the point 'b'. Also cracks will have appeared at the highly stressed areas 'a' and 'd'.

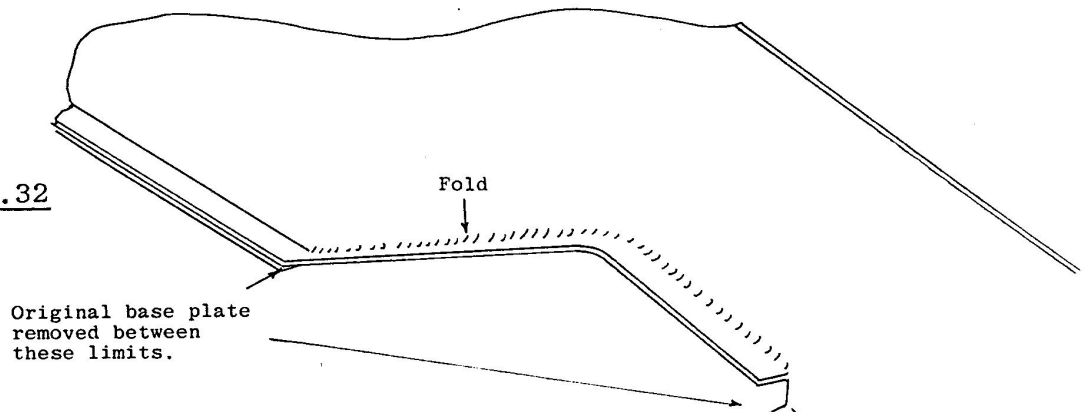
Fig.32

CHASSIS MODIFICATION AS ON C.1902

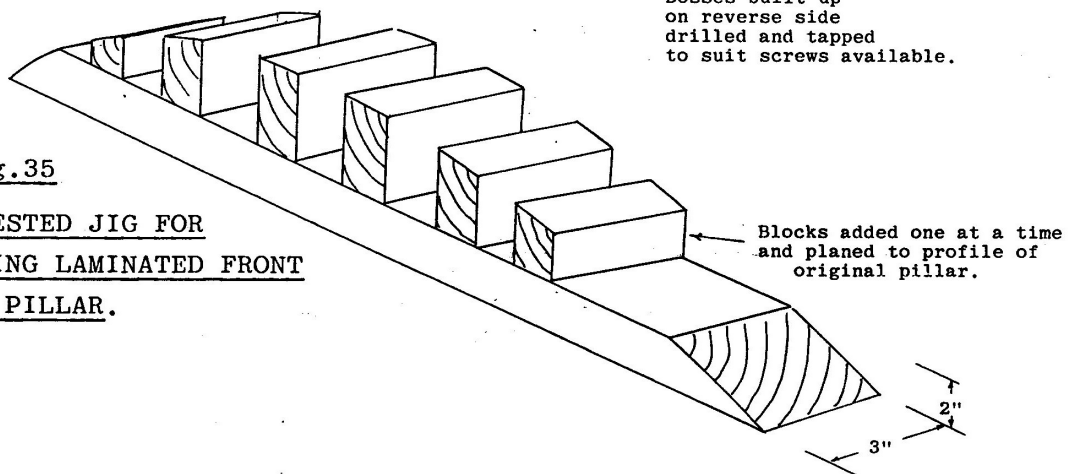
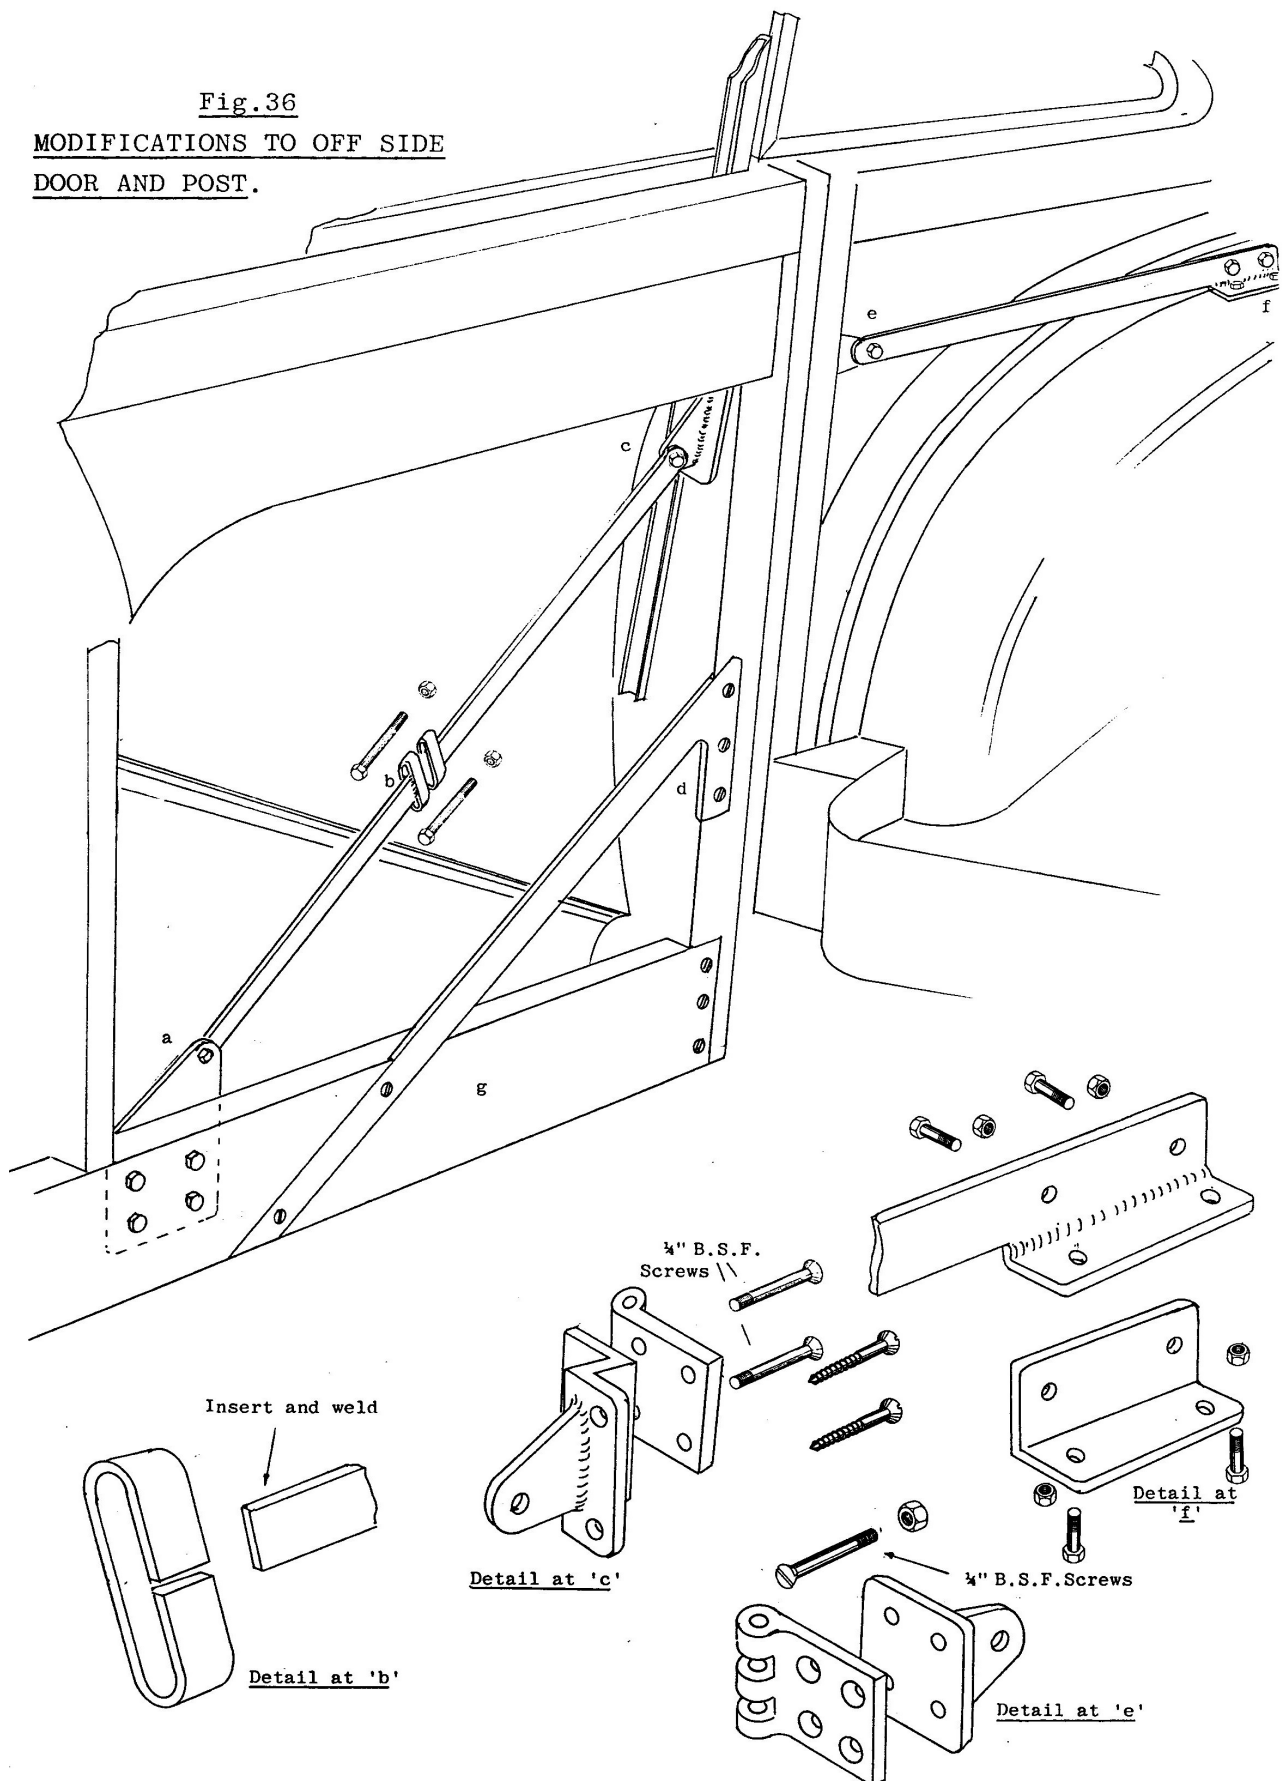
Fig.36

Once all the preceding items have been considered, it will still be apparent that the door is subjected to considerable stress when the body is subjected to bending or twisting loads, yet both the hinges and door catch arrangements are secured by quite small wood screws. Figs.35 and 36 suggest some modifications based on those used on C1902, although my steel door pillars and inertia reel seat belt mounting are additional refinements.

MODIFICATIONS TO OFF SIDE
DOOR AND POST.

With reference to Fig.36, the bracket (e) is bolted to the back of the door pillar by c/s headed screws through the rear half of the top hinge. The rear end of a steel tie is bolted to the wheelarch, the front to the bracket (e) with a reinforcing angle piece underneath. This relieves the surrounding woodwork of all stress.

Inside the door, there is already a plate (c) which passes behind the window running channel, and a lug can be welded to this as shown.

A hard alloy plate (a) is bolted to the board (g) which must be in good condition (mine is now made from 1/2" marine ply, which gives greater strength around the screw holes at its ends). The ties (a—b) and (b—c) can be made of 1/2"x1/8" steel strip, two pieces being shaped as shown, and welded on, so that two nuts and bolts can be used to adjust the tension. By this means the bottom of the door can be pulled inward and upward so that it closes slightly before the top, thereby ensuring freedom from rattle, and compressing properly any draught excluder one may fit along the lower edge.

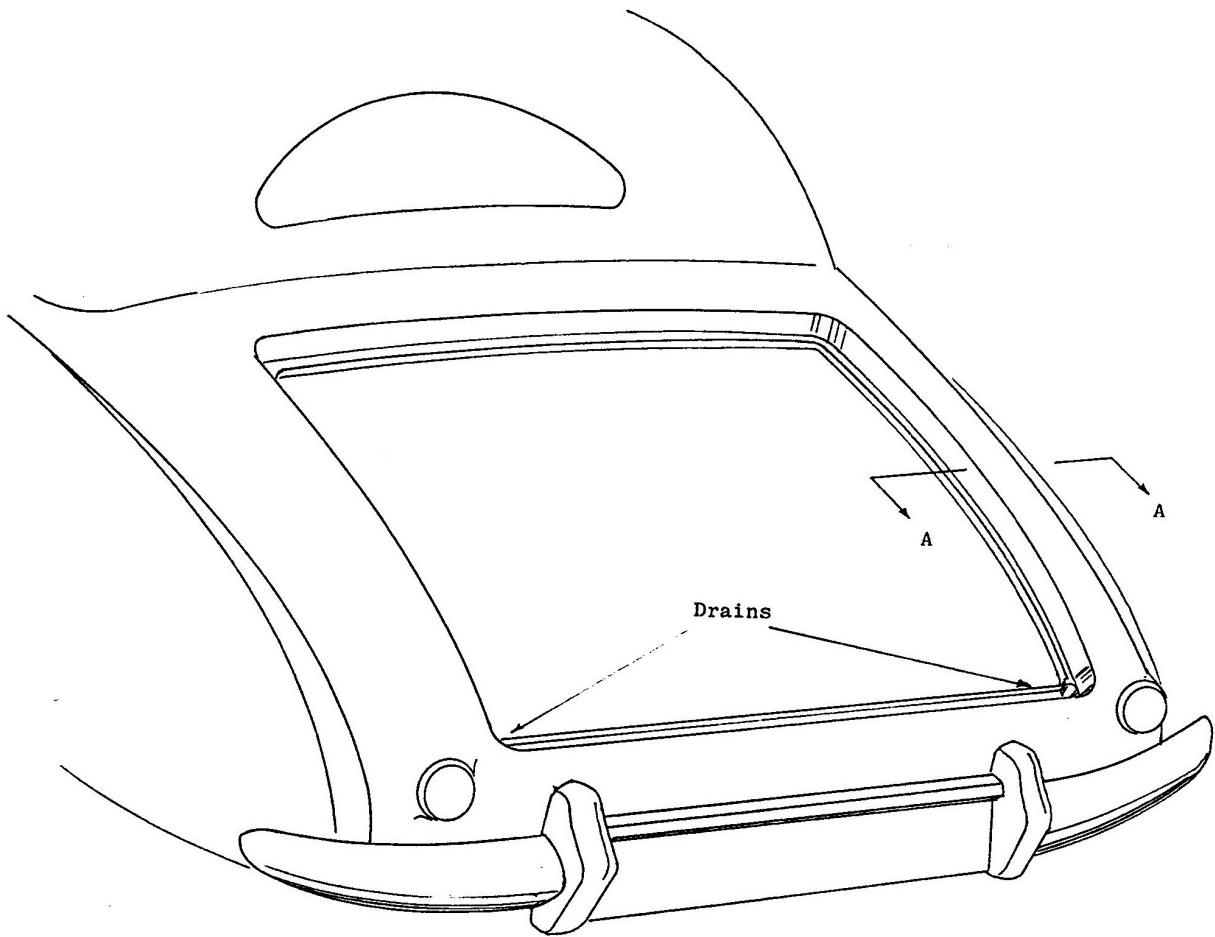
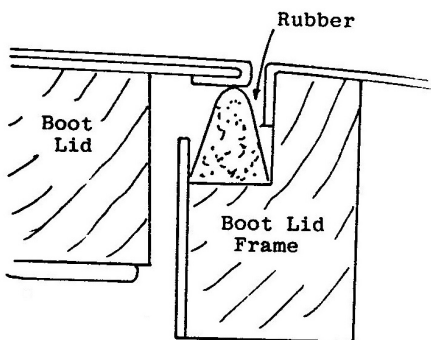
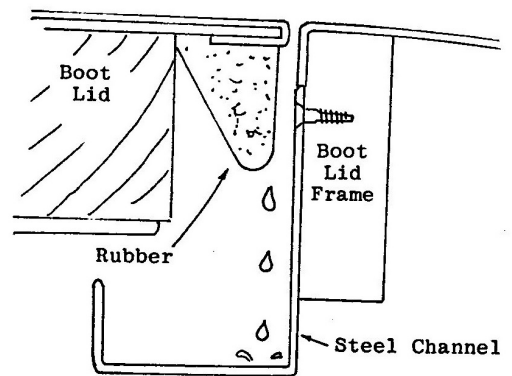
Fig. 37. MODIFICATION TO BOOT LID SEAL ARRANGEMENTS.

Finally, I would like to suggest that the boot lid aperture be modified to eliminate the problem of water leaking into the boot and into the adjacent timber, and to stiffen the aperture, thus reducing the tendency of the paintwork, and perhaps even the aluminium to crack at the corners.

Fig.37 shows how C.1902 is modified. The timber which supports the rubber seal is cut back flush to remove the existing rabbet. A steel channel is then fabricated to surround the entire aperture. A drain pipe of about 1" diameter at each bottom corner carries the water through the bottom of the boot by means of plastic piping. A triangular sealed section rubber is then glued to the under- side of the edge of the boot lid to ensure that the water falls into the channel without touching the boot lid timber. This modification also solves the

problem of the boot lid sticking shut during freezing conditions, as the rubber is no longer in contact with the body.

In the case of C.I902, the channel was made from some redundant office partitioning. Starting with a 2"x2" x 16 s.w.g. angle, the necessary curvature was formed by heating and stretching one edge of the plate at intervals of about 1 1/2". The four sides were then formed into the desired shape at the corners and welded together. The assembly was then sprayed body colour, and fitted into position with a sealing compound and secured with 2" stainless steel screws. Most of the modifications in this article were carried out on CI902 in the 1960's restoration, and have been proven by time and 100,000-+ miles since.
